# Universal Inspect

## SUMMARY REPORT

**Client:** Mario A. Martinez  
**Realtor:** Sandra Gonsalves, Coldwell Bankers Allstars  
**Inspection Address:** 8434 San Juan Ave, South Gate, CA 90280  
**Inspection Date:** 7/11/2013 Start: 10:00am End: 12:30pm  
**Inspected by:** Brett Mars

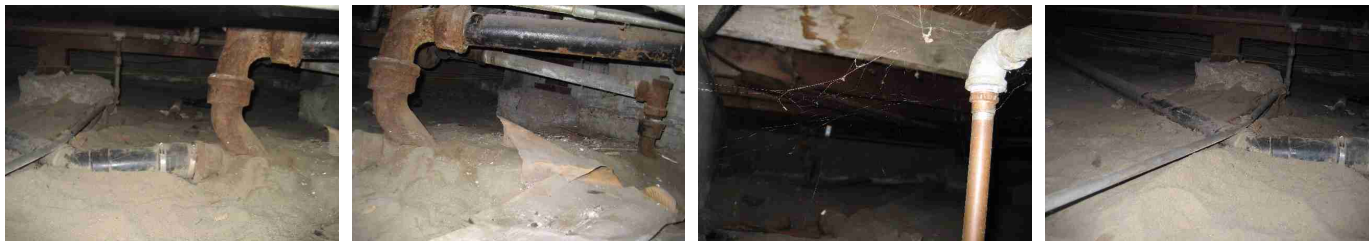
The foundation was constructed in the early nineteen-hundreds and would be costly to retrofit to meet current standards, and which could mean rebuilding it. The concrete/bricks that was used at the time was a poor quality that has a tendency to soften and deteriorate due to its ability to easily move. Also, the dimensions of

the footings were less, and therefore simply adding bolts to soft undersized footings may add some seismic value but nothing that would approach current standards.

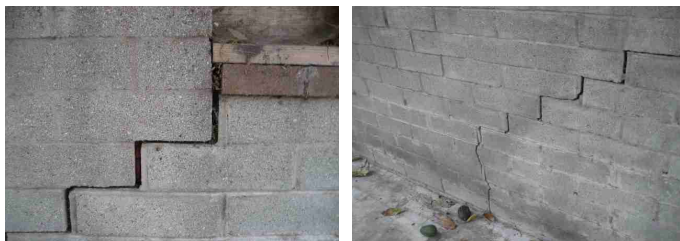
The cinder block yard walls have stress fractures, open grout joints or loose and missing blocks, and should be serviced.

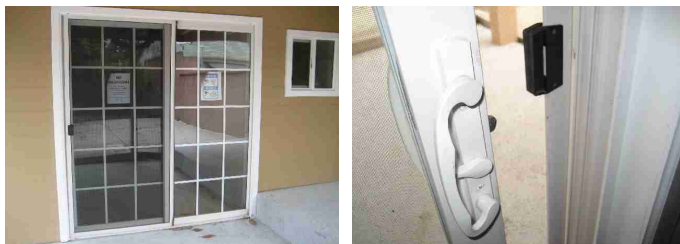
Do not have a lock and should be fixed.

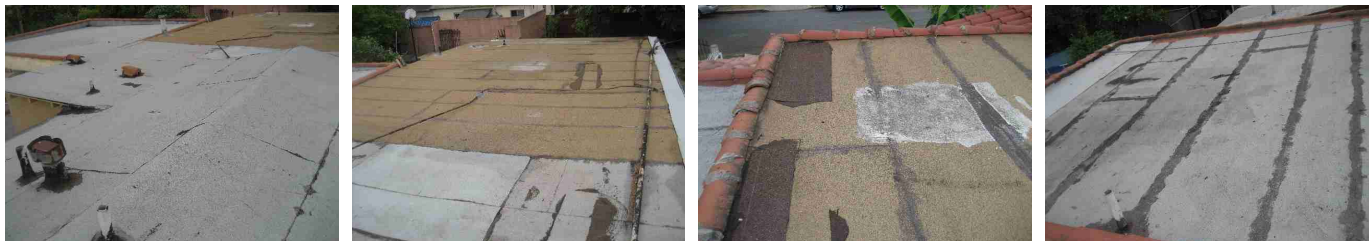
The roof is old and beyond its design-life. WE STRONGLY RECOMMEND GETTING THE ROOF CERTIFIED BY A LICENSED ROOFING CONTRACTOR BEFORE CLOSE FOR ESCROW.

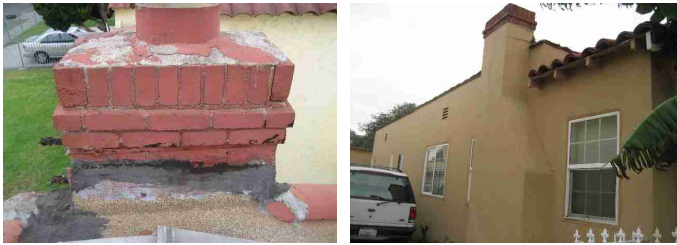
The chimney is a lined masonry type, which is the most dependable because the flue liner not only provides a smooth transition for the bi-products of combustion to be vented beyond the residence but provides an approved thermal barrier as well. However, we recommend a level-two inspection by a qualified specialist within the contingency period or before the close of escrow, as recommended by NAPA standards "upon the sale or transfer of a property."

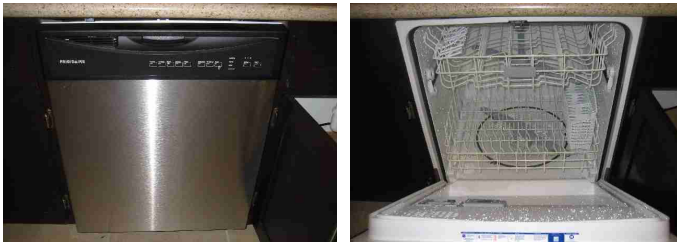
The dishwasher is functional but is too hard to close.
